Report Job No. 1605

Subject- Report: [REDACTED] Mandurah 6210

WP Technologies is pleased to submit our report for water entry to [REDACTED] Mandurah 6210, as per site inspection.

1. Strata Report

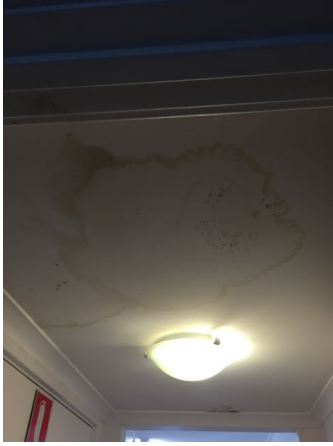
Pic A

After inspection on [REDACTED], there are signs of water damage/water staining to the ceiling above the entrance area (*pic A & B*). After initial inspection we can assume the damage is caused by a moisture entry issue from the roof area above. On inspection no water can be seen ponding on internal hanging ceiling, as the internal brick wall is blocking visual access to this area.

The pictures taken show visible water damage at time of inspection (*pic A*), however without removing roofing components around this area, we cannot be 100% sure as to a possible cause.

The main cause for concern at this point would be moisture entry to the building from any of the above areas mentioned. Water entry to the area is confirmed (*pics A & B*) and leak testing could be completed to determine the course of action to be implemented that will lead to resolving the concern.

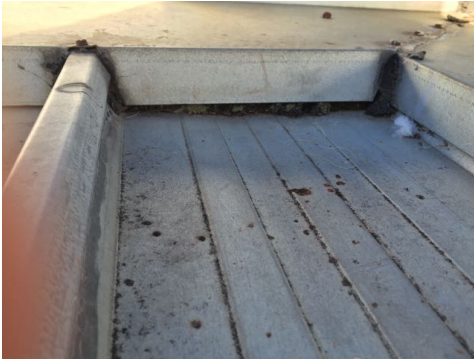
Pic C

- i) The roof edge flashing/capping (*pic C & D*).
- ii) The roof tile areas above (*pic F*).
- iii) The plant area roof area penetrations (*top edge of pic H*).
- iv) The box gutter in plant area roof (*pic G-J*).

- i. Gain access building plant roof and install silicone to all flashing/capping junctions
- ii. Complete visual inspection to all penetrations and seal as required.
- iii. Install new box gutter and box gutter support ensuring fall is corrected to not less than 5mm per Lm of guttering.

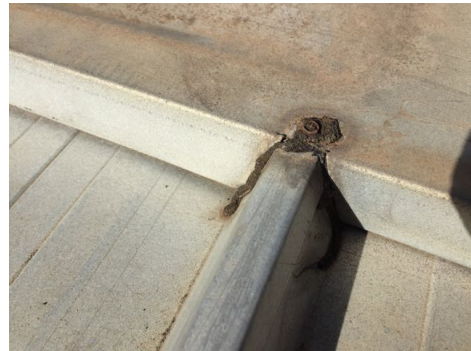
Pic D

Compounding to this water entry, is the possibility the roof flashing/capping area could be a source of water ingress. The initial black bitumen sealant between flashing/capping and roof sheeting has broken down and letting water pass through, as seen in (*pic D*).

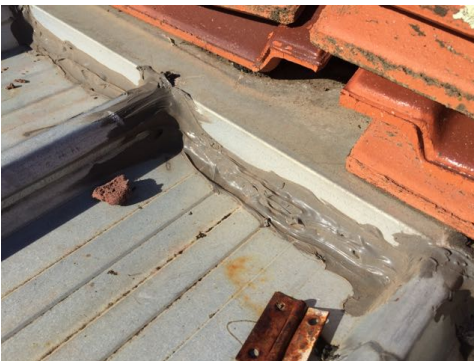
Pic E

1. Roof tiles removed and replaced.
2. Silicone/Polyurethane to flashing/capping (*pic E*).
3. New PVC piping put through roof or modifications completed.
4. Bitumen waterproof bandage installed to box gutter lap joints (*pic J*).
5. Various silicone installations around the plant roof area.

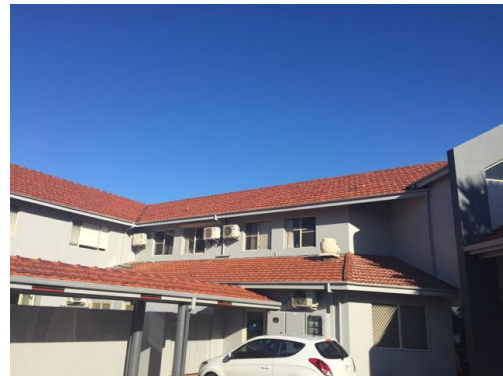
Pic F

The roof tiles appear to be in good order, some minor cracking in the pointing but nothing worth noting at this time.

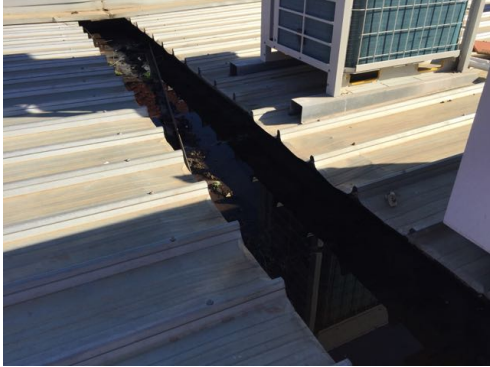
Pic G

In my opinion the main water ingress is from the box gutter (*pic G-J*) being directly above the leak and in poor condition. The box gutter contains ponding water and the lap joints are showing signs of deterioration. Box gutters are a common source of water ingress to buildings and in this case, more than likely the source of water ingress. As you can see in (*pic G & I*) the box gutter lacks enough fall to transport water though to drain end, this will also need correcting.

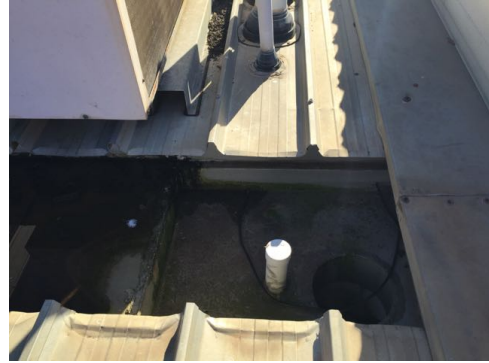
Pic H

All roof penetrations appear to be ok, but resealing is recommended to a select few.
